# **777-200/200LR/300/300ER/777F**

## **MAINTENANCE PLANNING DATA (MPD) DOCUMENT**

#### **AIRWORTHINESS LIMITATIONS (AWLs) AND CERTIFICATION MAINTENANCE REQUIREMENTS (CMRs)**

**D622W001-9**

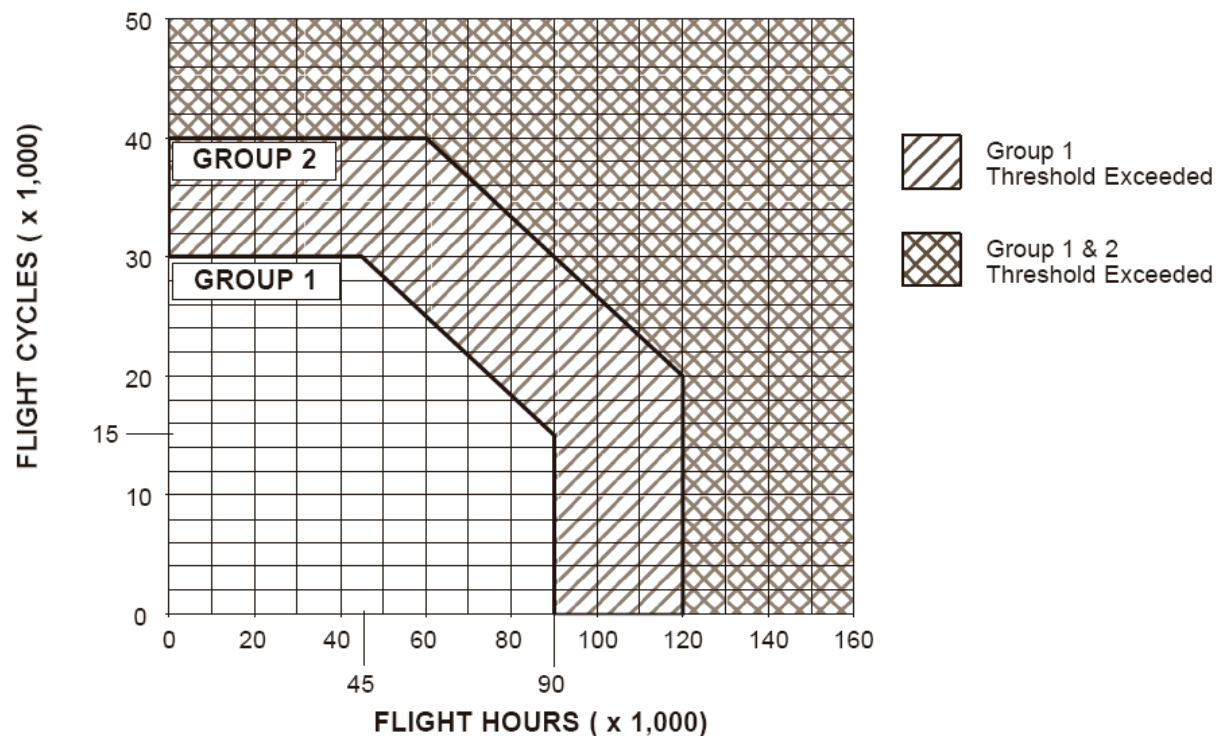
FIGURE 1. FLIGHT LENGTH SENSITIVE (FLS) THRESHOLD CURVE (777-200/200LR/300/300ER ONLY)

NOTE: In Figure 1 and the discussion of flight length sensitive threshold that immediately follows this note, "777-200" includes airplanes sometimes referred to as 777-200ER or 777-200IGW since those airplanes are certified as 777-200 airplanes per the applicable FAA Type Certificate.

1. Inspection must be accomplished at or before the stated threshold value.
2. Group Number is provided to determine applicable plot in Figure 1 or 2 for items identified as "FLS".
3. Thresholds that include "FLS" (e.g., "> 7 Hrs, FLS, See Figure 1 or Figure 2") are sensitive to flight length. All other values shown are in flight cycles.
4. No airplane may be operated beyond the stated threshold (or operational limit) until the applicable inspection procedures are validated, published in the appropriate manual, and accepted by the FAA.

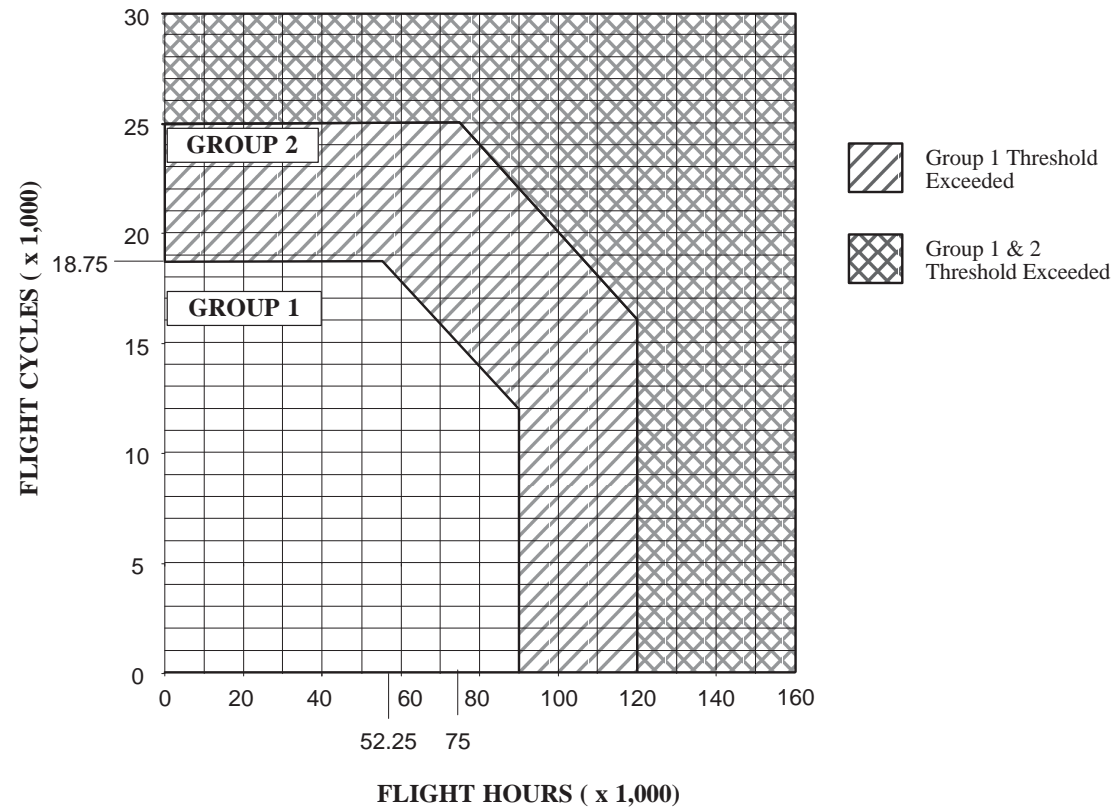
FIGURE 2. FLIGHT LENGTH SENSITIVE (FLS) THRESHOLD CURVE (777F ONLY)

#### USE OF FLIGHT LENGTH SENSITIVE THRESHOLD CURVE (777F ONLY)

| SSI # <sup>(2)</sup> | DTR CHECK FORM TITLE <sup>(3)</sup> | DTR LOCATION | GROUP <sup>(4)</sup> | APPLICABILITY/THRESHOLDS <sup>(1,5,6)</sup> | | | | | |
|---|---|---|---|---|---|---|---|---|---|
| 57-54-I19A | 112W1752, MLG Drag Brace Support Fitting | Section A-A Flange Crack | 2 | | | | | | > 7 Hrs, FLS, See Figure 2 (7) |

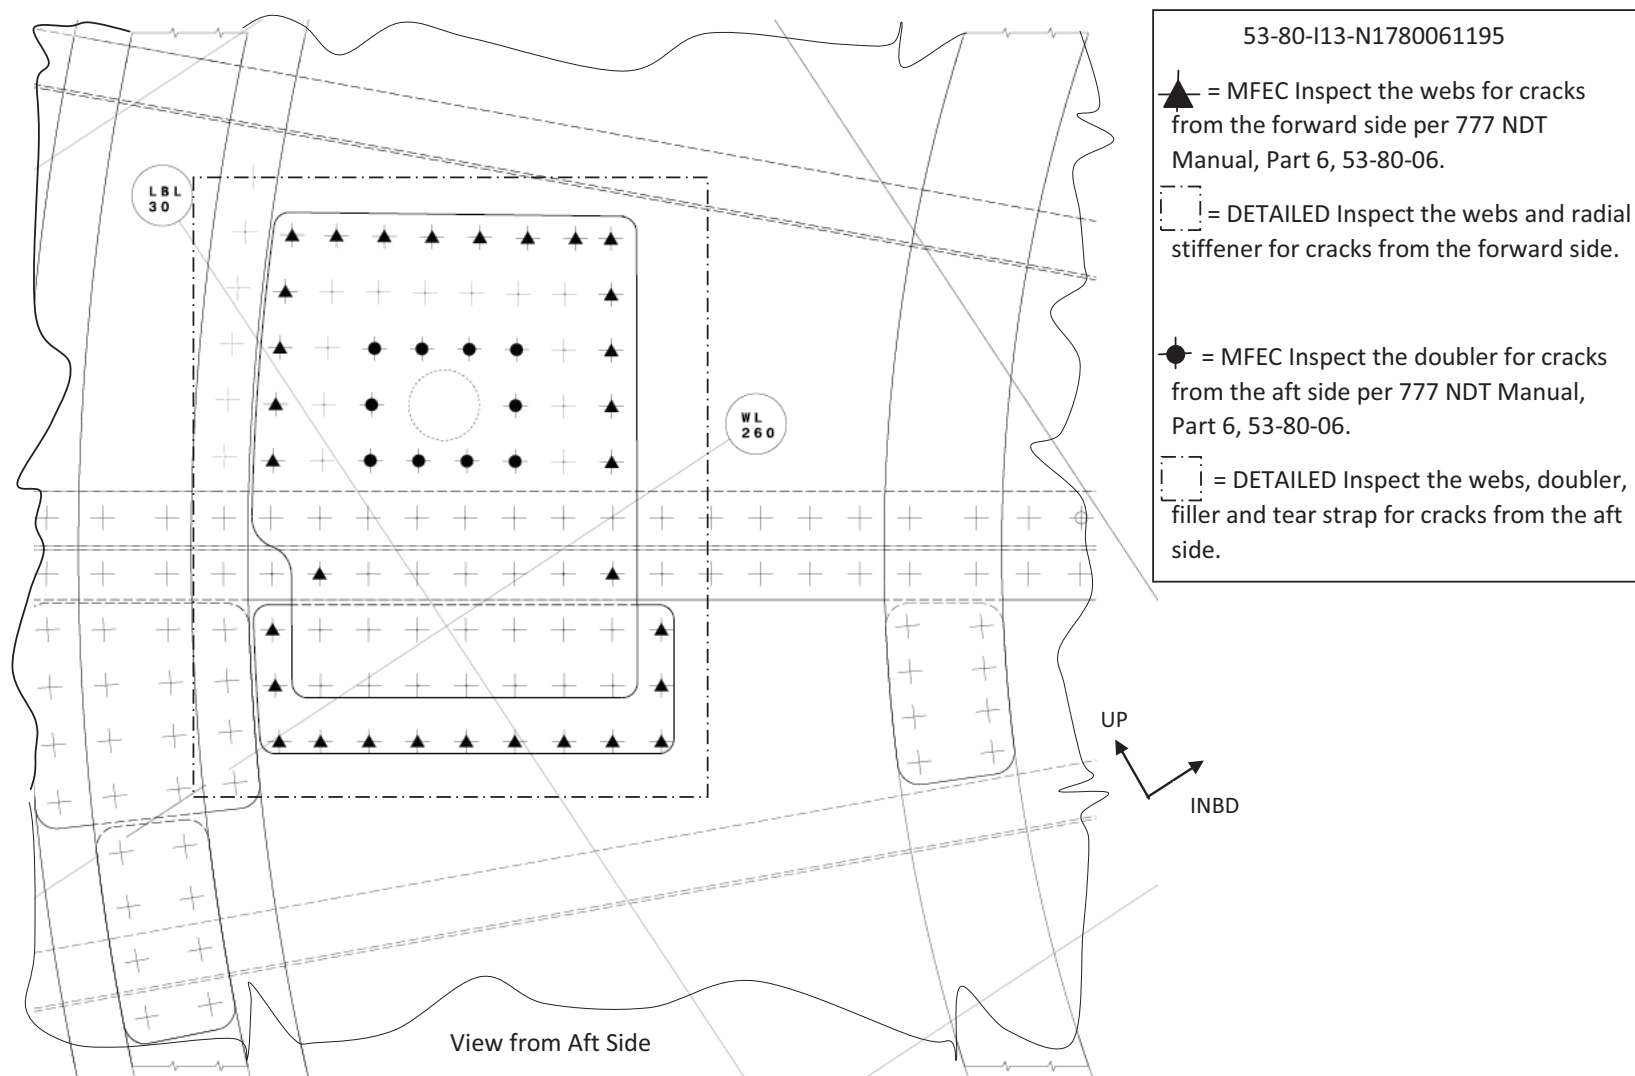
FIGURE 3. 53-80-I13-N1780061195 - Aft Pressure Bulkhead Web Rework, NCR N1780061195

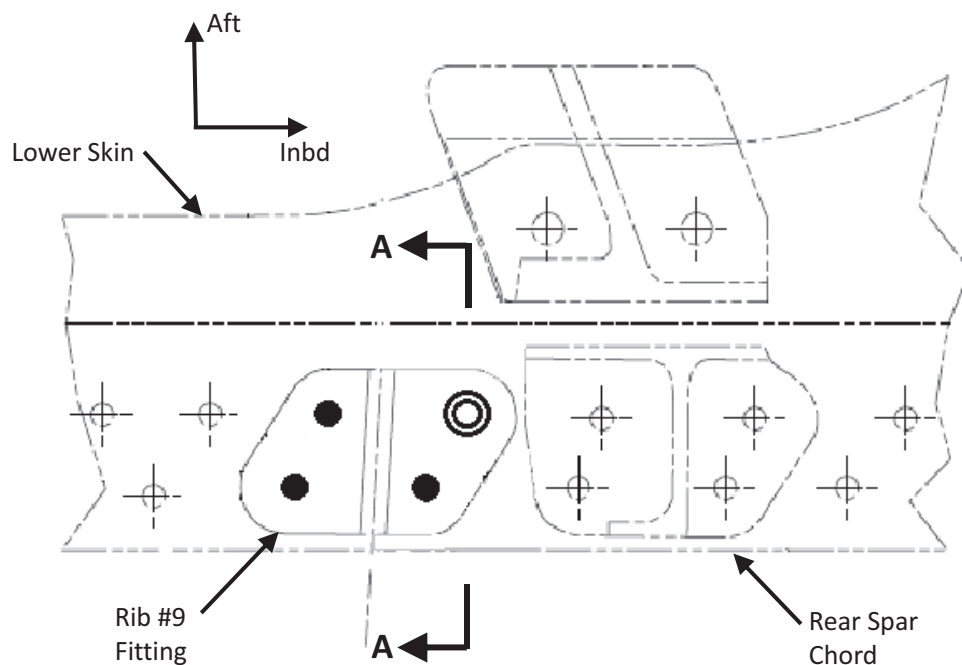
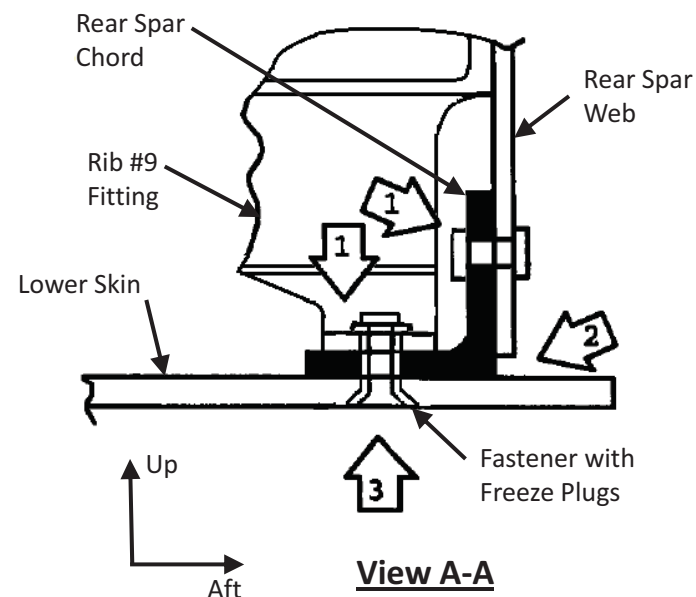
- Fastener with Freeze Plugs  
 Adjacent fasteners requiring inspection for SSI 57-20-I01G  
 Other fasteners (reference)

In the reworked area, perform the following inspections:

- 1) From direction 1, HFEC inspect the rear spar lower chord per the 777 NDT Manual Part 6, 51-00-01. Use the lower chord edges, radius, Rib #9 fitting shear tie foot and fastener collars on the vertical leg as a probe guide.
- 2) From direction 2, HFEC inspect the rear spar lower chord per the 777 NDT Manual Part 6, 51-00-01. Remove sealant as required. Use the rear spar web lower edge as a probe guide.
- 3) From Direction 3, inspect the rear spar lower chord at the freeze plug fastener location per 777 NDT Manual Part 6, 57-20-01.
- 4) Inspect the remaining 3 adjacent fastener locations as required for SSI 57-20-I01G.

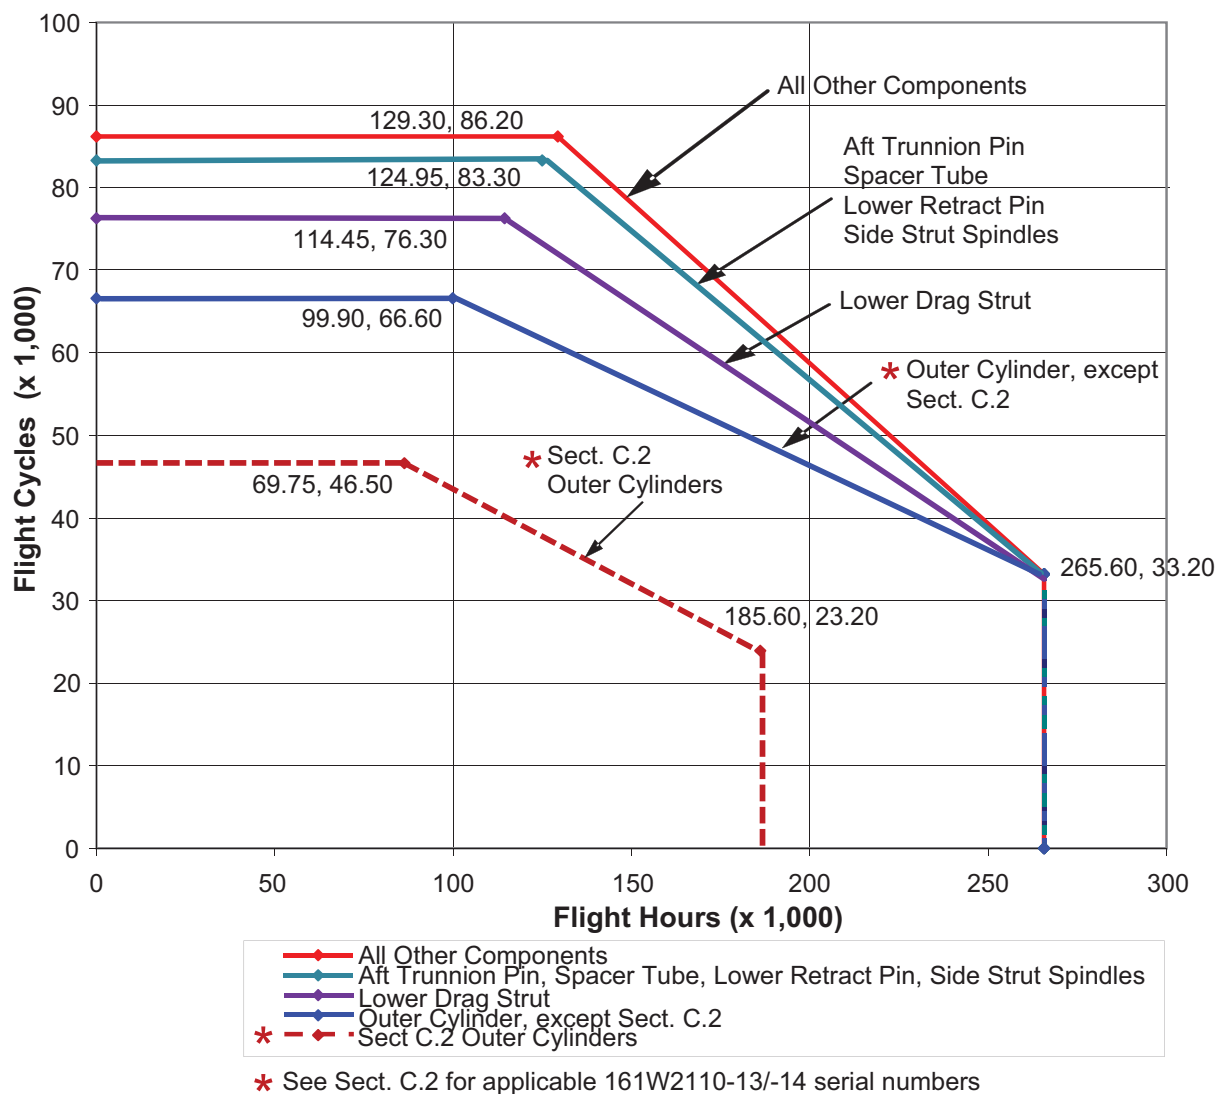
FIGURE 5. 777-200LR/300ER/777F MAIN LANDING GEAR SAFE-LIFE LIMITS

Revised Figure 5: 777-200LR/300ER/777F MLG Safe-Life Limits to reflect the addition of the life limit curve for outer cylinders as indicated in Section C.2.

| 777-200LR/300ER/777F Main Landing Gear | Figure 5 (FAA & EASA) | |

| COMPONENT: | LIFE LIMIT: |
|--|---|
| 777-200LR/300ER/777F Main Landing Gear Outer Cylinder<br><br>NOTE: Life Limitation applies to P/N 161W2110-13 (LH) and 161W2110-14 (RH) Outer Cylinders with Serial Numbers:<br><br>161W2110-13: S/N WHM5001, WHM5002, WHM5003, WHM5007, WHM5017, WHM5021, WHM5023, WHM5033, WHM5039, WHM5041, WHM5045, WHM5047, WHM5053.<br><br>161W2110-14: S/N WHM5002, WHM5003, WHM5008, WHM5010, WHM5012, WHM5014, WHM5020, WHM5032, WHM5036, WHM5040, WHM5046, WHM5048, WHM5052. | Figure 5 |

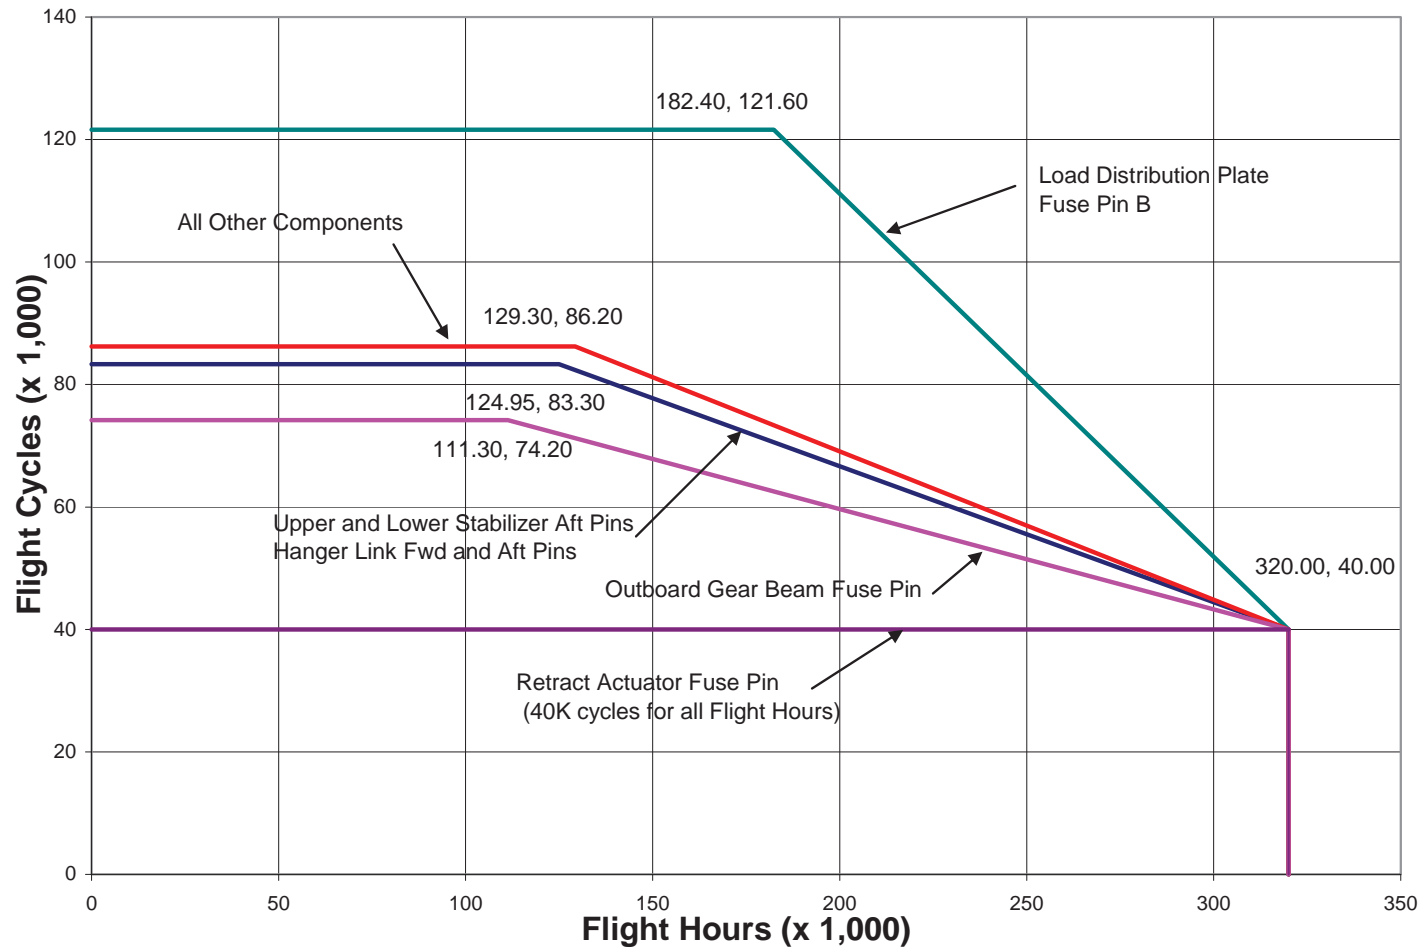
### Main Landing Gear Support Fittings Safe-Life Limits

FIGURE 6. 777-200LR/300ER/777F MAIN LANDING GEAR SUPPORT FITTINGS SAFE-LIFE LIMITS

| 777-200LR/300ER/777F Main Landing Gear Support Structure | Figure 6 (FAA & EASA) | |

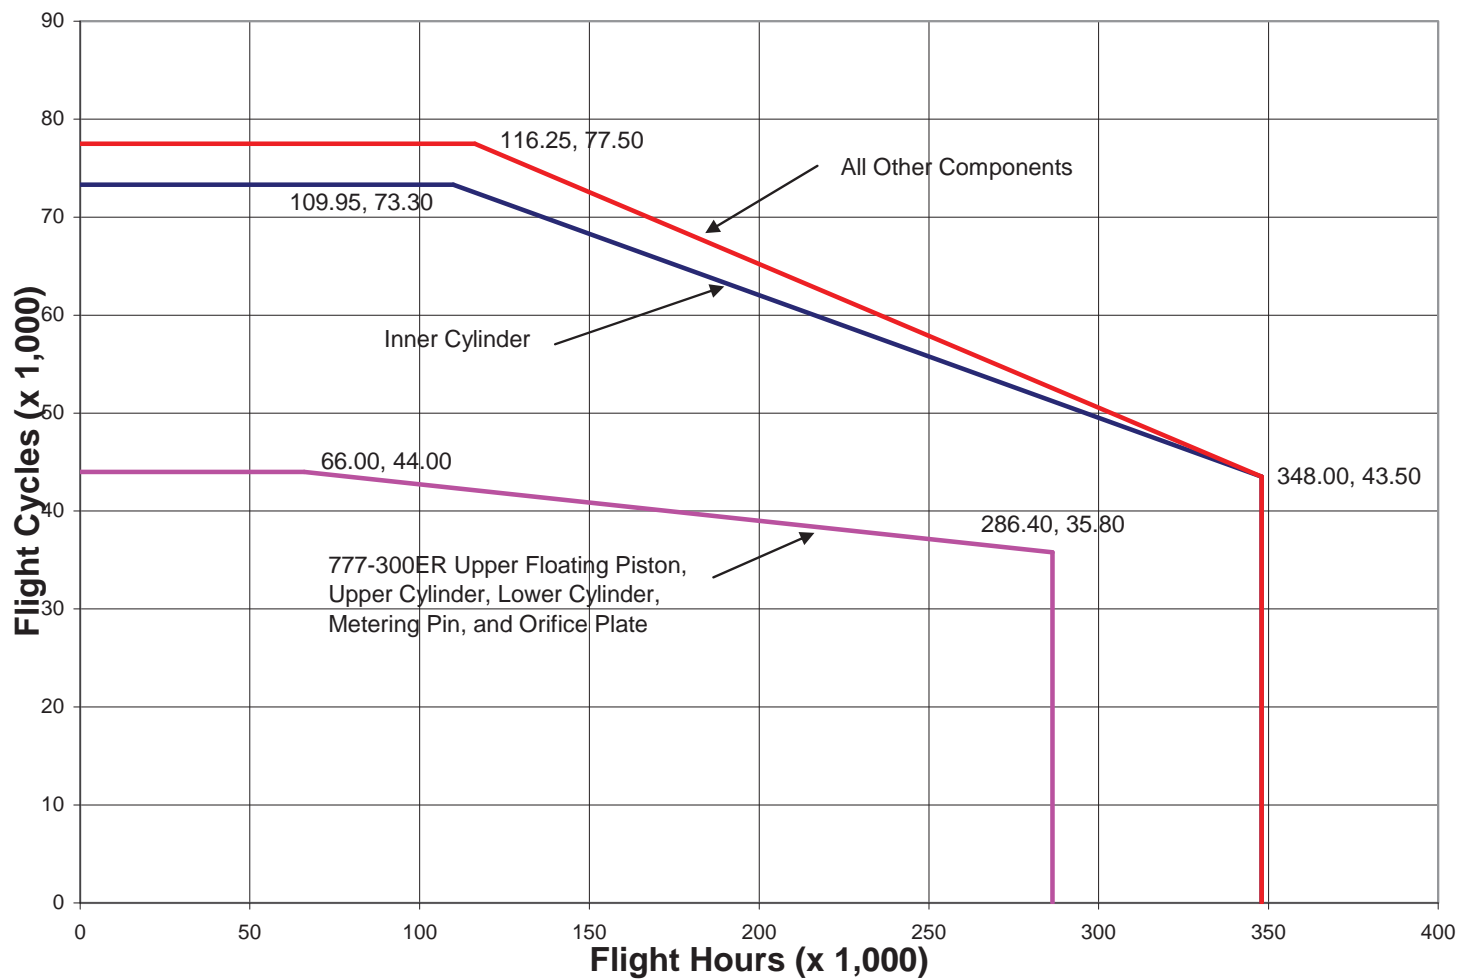
### Nose Landing Gear Safe-Life Limits

FIGURE 7. 777-200LR/300ER/777F NOSE LANDING GEAR SAFE-LIFE LIMITS

| 777-200LR/300ER/777F Nose Landing Gear | Figure 7 (FAA & EASA) | |
